## Enviro Clean Product Application Example

### EnviroClean® Product Example – Spill Response Hennessey, Oklahoma

### EnviroClean® Product Example – Spill Response

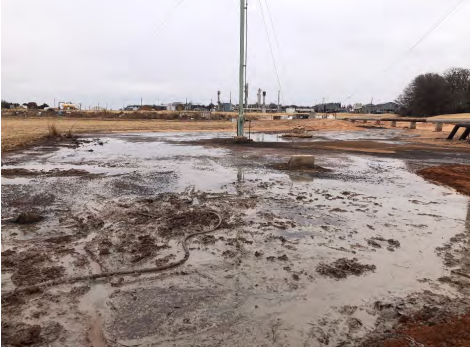
Initial Site Conditions after Release

On December 4, 2018, ECS was contacted by our client requesting ECS to respond to a release at their site location. Fluids released had already been suctioned out of the impacted area.

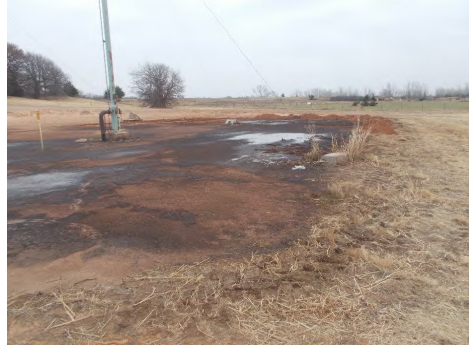
Site Conditions after Suctioning  
Residual Release Fluids

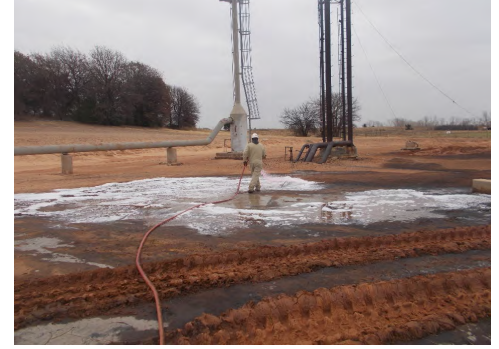
Application of EnviroClean® Solution over  
Impacted Area

The team treated the impacted area by spraying an Enviro Clean® solution over the impacted soils.

Approximately 25-gallons of EnviroClean® product was used to treat the area.

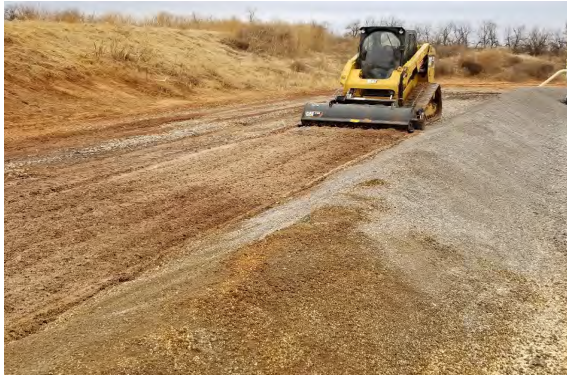
Till-and-Treat of Impacted Area

On January 11, 2019, ECS returned to the site to begin tilling-and-treating the impacted areas. A job safety analysis (JSA) and safety meeting was completed before ECS began till-and-treat activities. ECS personnel mechanically tilled the impacted area, approximately 30 feet by 130-feet, to an approximate depth of six-inches bgs.

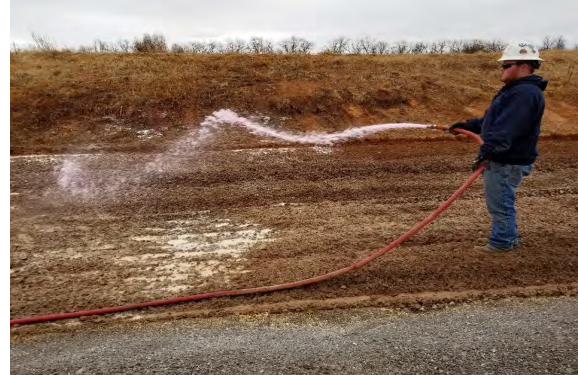
Application of EnviroClean®  
Treatment over Impacted Area

Once all tilling was complete, the tilled area was treated with EnviroClean® solution. Approximately 20-gallons of EnviroClean® solution was used to treat the impacted area.

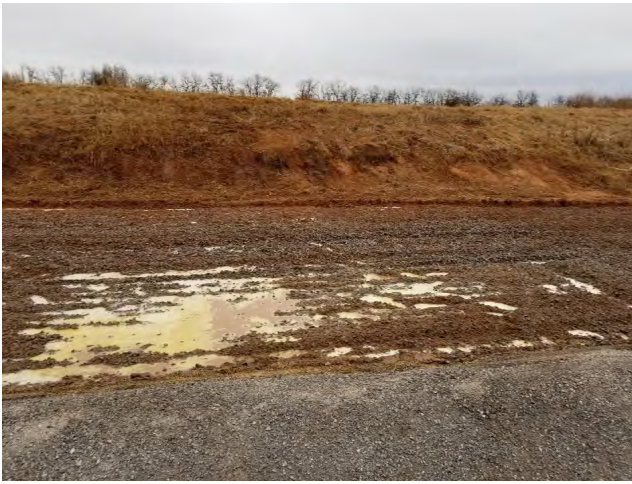
Tilled-and-Treated Impacted Area

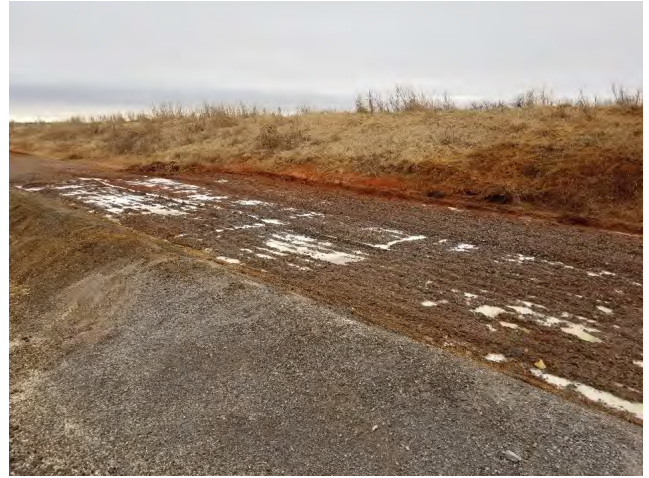
Tilled-and-Treated Impacted Area
